## Repair instruction

**Description: C2 C3 C4 (produced after 15 June 2000) Lip seal**

**Part number: 23721**

<b>Version:</b>	V2
<b>Date:</b>	13/07/2006
<b>Tools required:</b>

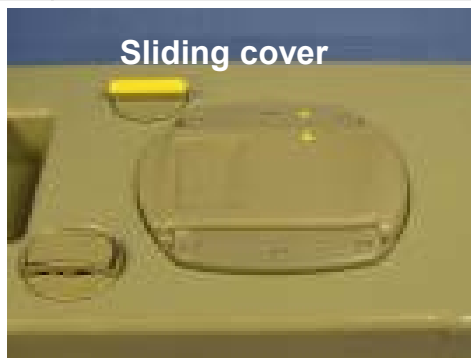
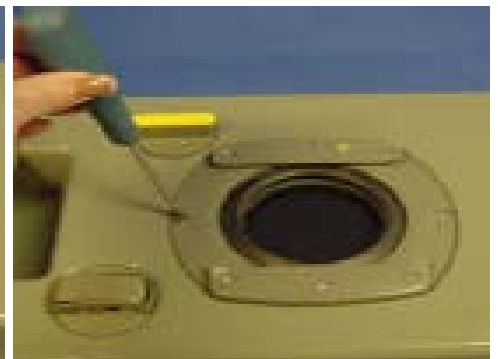
**A**

Remove the sliding Cover.

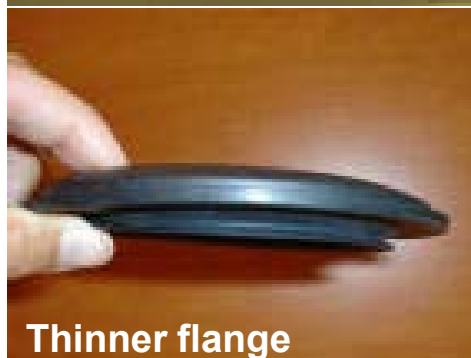
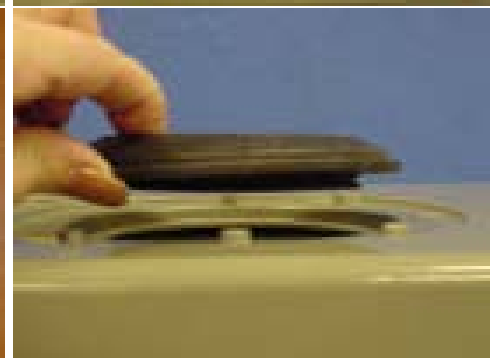
**B**

Unscrew the 8 screws on the seal cover and, take the seal cover off.

Place new lip seal on the waste tank.  
**Note:** Thinner flange has to face downwards towards the blade.

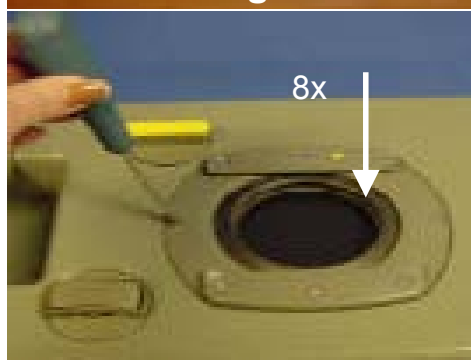
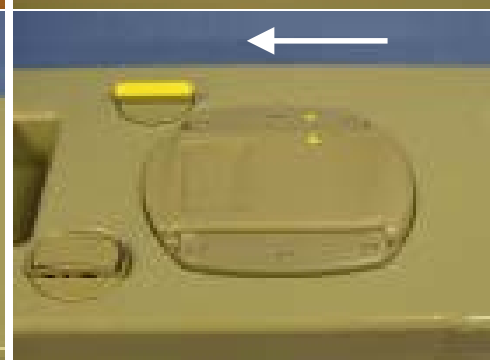
**C**

Place the lip seal on the waste tank.

Screw the seal cover back onto the waste tank.

Place sliding cover back on its place. Make sure that the two arrows are pointed to each other.
